Experience with Rural Wildlife Detection and Warning Systems

National Rural ITS Conference

Erik Minge, PE

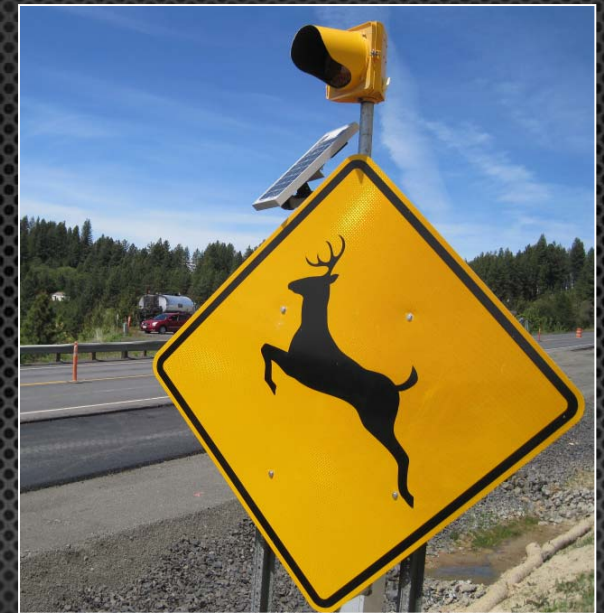
SRF's Focus has been on active detection and driver warning, instead of wildlife behavior modification

Active warning systems have been shown to reduce collisions with large hoofed animals by 82 percent (*Romer, J., and C. Mosler-Berger, 2003*)

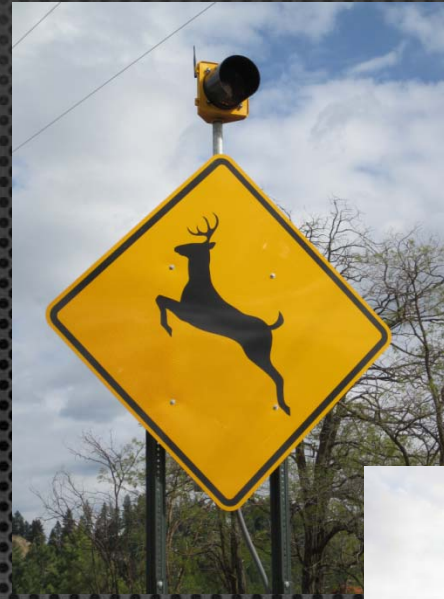
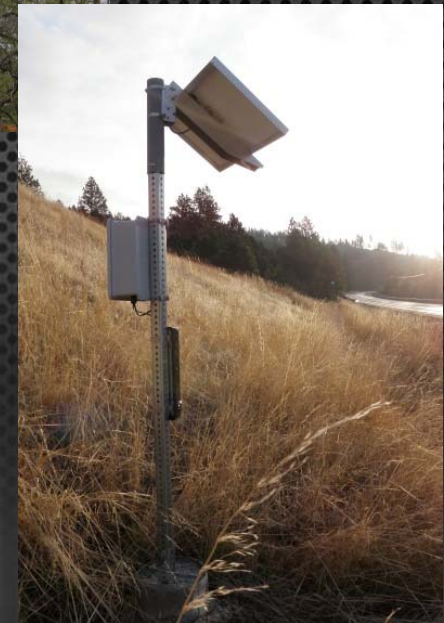
System Details

- Three main components at the roadside:
 - Signs
 - Detectors
 - Management Station (for remote monitoring)
- Designed to be small, crash worthy and use renewable energy

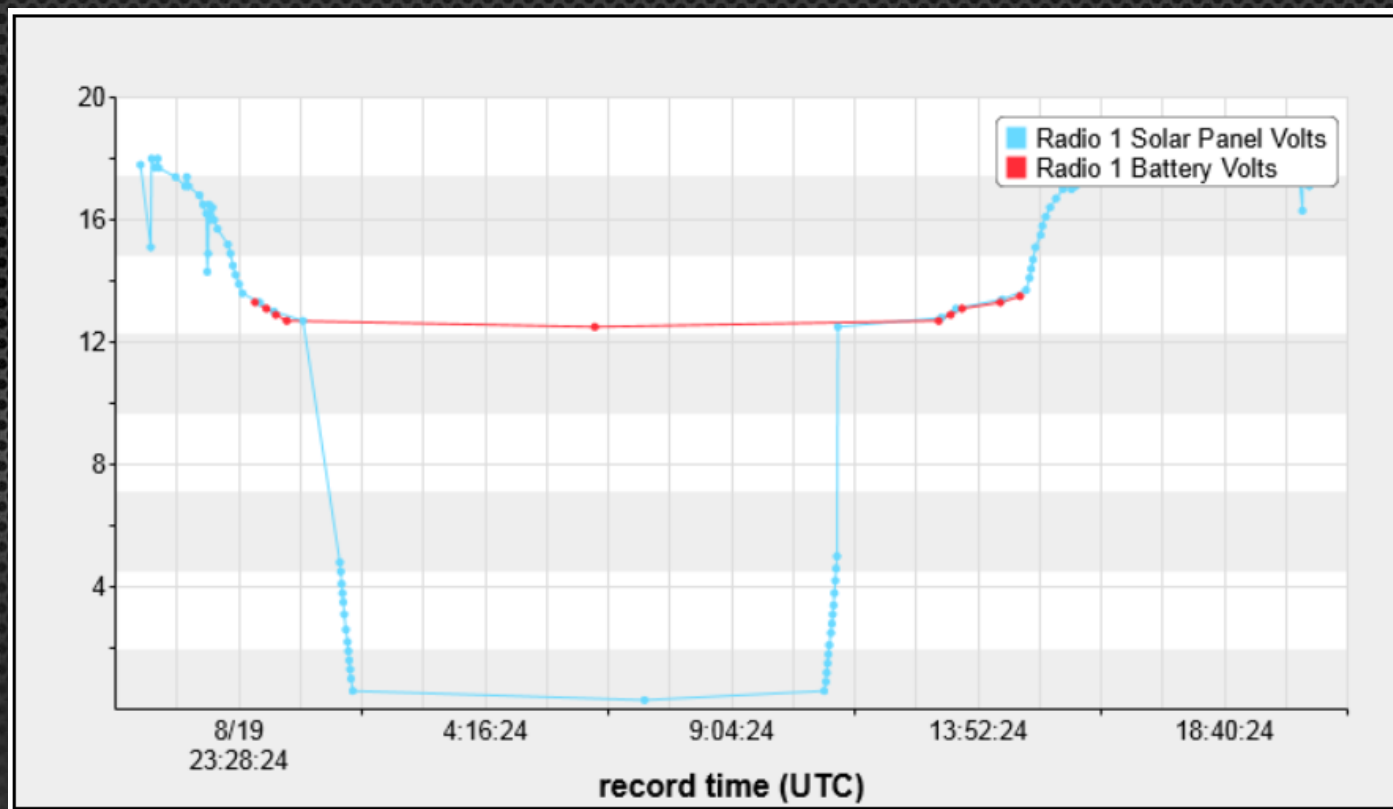
- Power System Monitoring Example

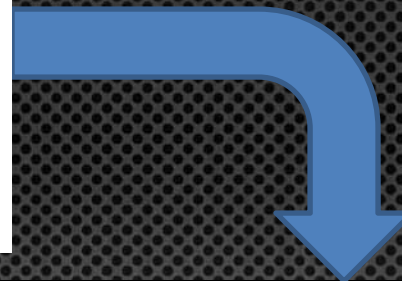
- Data Archiving and Download

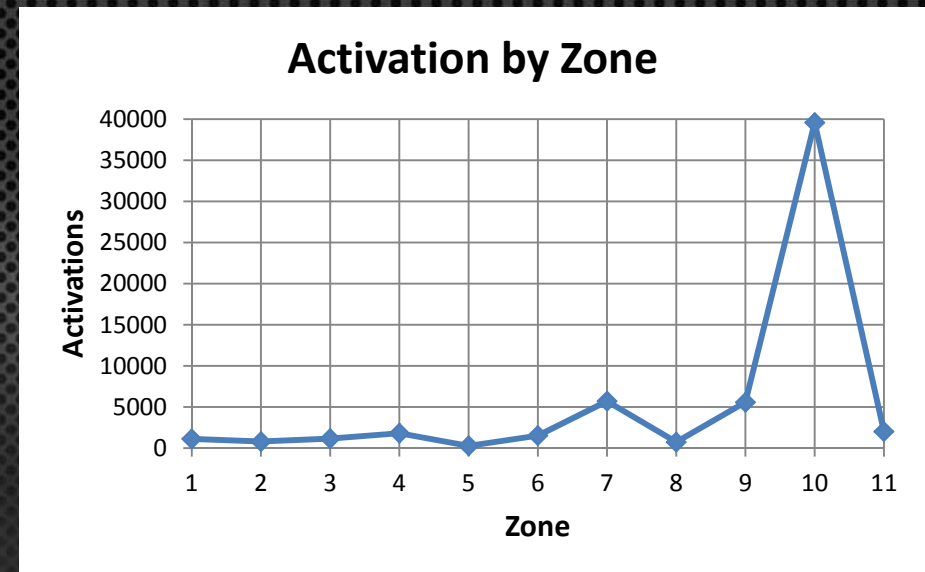
Operational Data

- Diagnostics can be derived from detector data
- “Spikes” in detection counts indicate grass growth between detectors
